MATERIALS RESEARCH FOR THE CLEAN UTILIZATION OF COAL

QUARTERLY PROGRESS REPORT

October - December 1979

Center for Materials Science  
National Bureau of Standards  
Washington, D. C. 20234

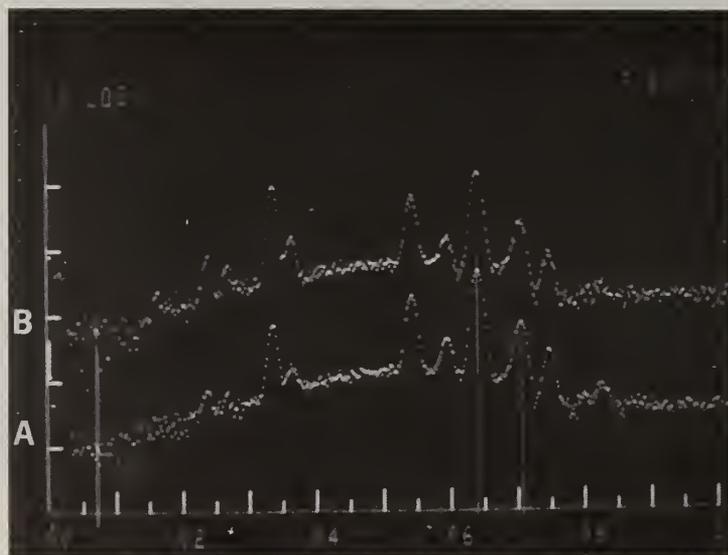
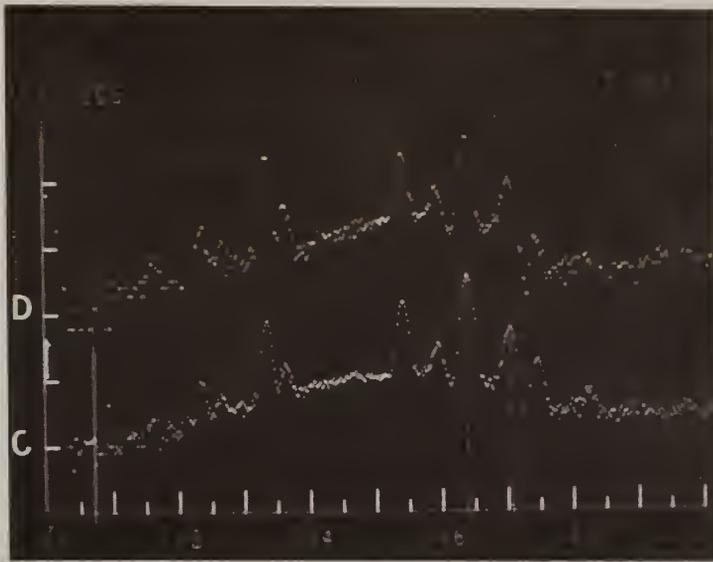
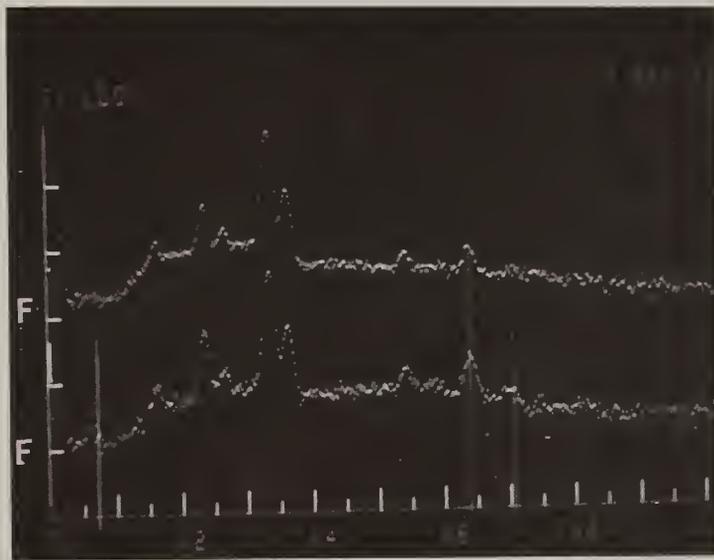
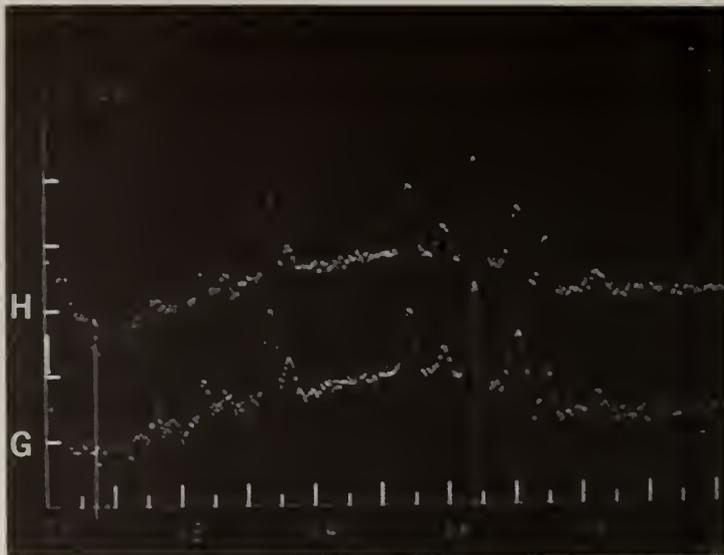
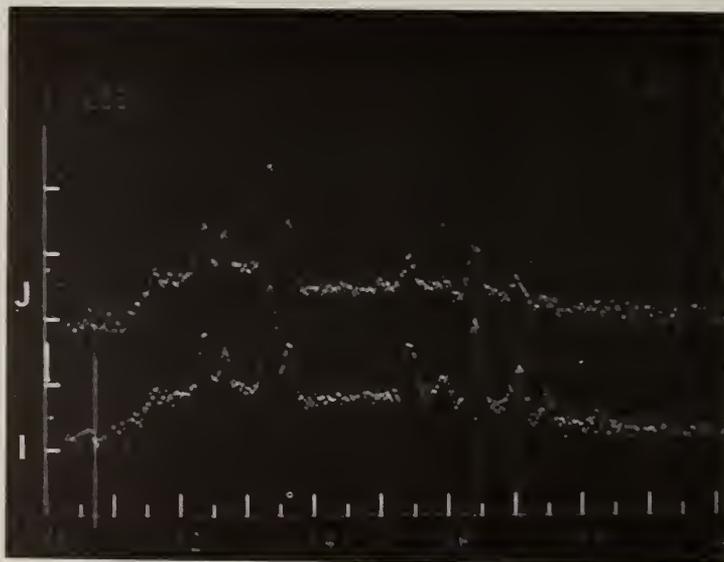
Fig. 9a. EDX spectra of regions A and B of Fig. 9 showing areas of low Ni concentration on the stainless steel interface.

Fig. 9b. EDX spectra of regions C and D of Fig. 9 showing areas of low Ni concentration on the stainless steel interface.

Fig. 9c. EDX spectra of regions E and F of Fig. 9 indicating Fe penetration into the salt deposit.

Fig. 9d. EDX spectra of regions G and H of Fig. 9 showing areas of low Ni concentration on the stainless steel interface.

Fig. 9e. EDX spectra of regions I and J of Fig. 9 indicating Fe and Cr penetration into the salt deposit.

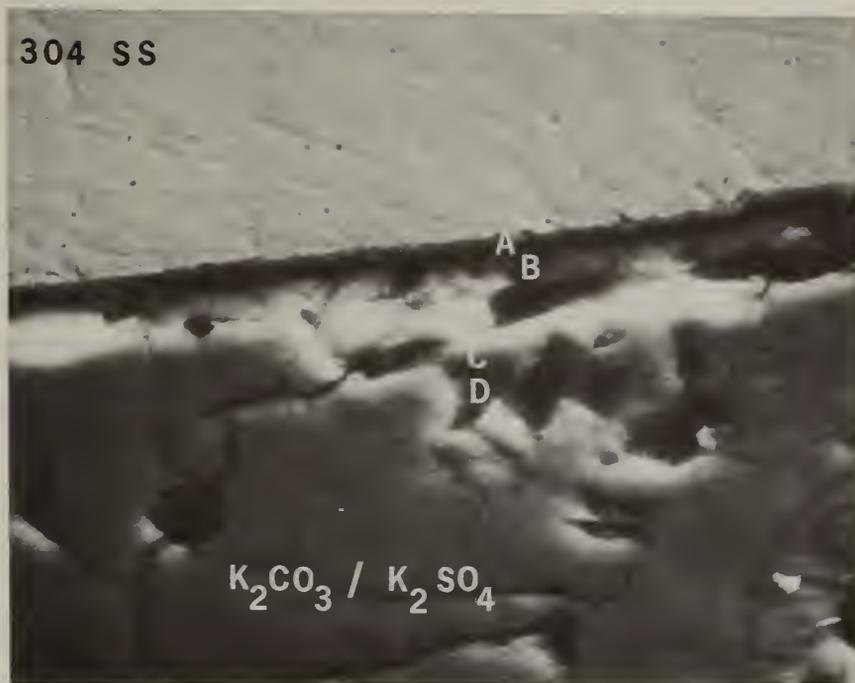
Fig. 10. SEM micrograph, 2000 X, of stainless steel-salt deposit reaction zone. Lettered regions correspond to labeled EDX spectra Figs. 10a and 10b. Specimen temperature 400°C; gas stream oxygen rich.

SEM/EDX analysis seems to indicate that preferential leaching of the metal cations from the bulk material (304 stainless steel) is found in a somewhat orderly fashion. The analysis shows that, moving from the stainless steel bulk material to the salt deposit, a high chrome concentration area is found along the edge of the tube and below the surface of the tube top. Areas of high nickel concentration are found within the high chrome concentration matrix while areas of high iron concentration are found next to the salt. Figures 9a-9f show that the iron is found in areas of high potassium concentration a good distance away from the reaction interface region of the stainless steel/salt deposit. Figures 10a-10c again show iron well away from the reaction zone.

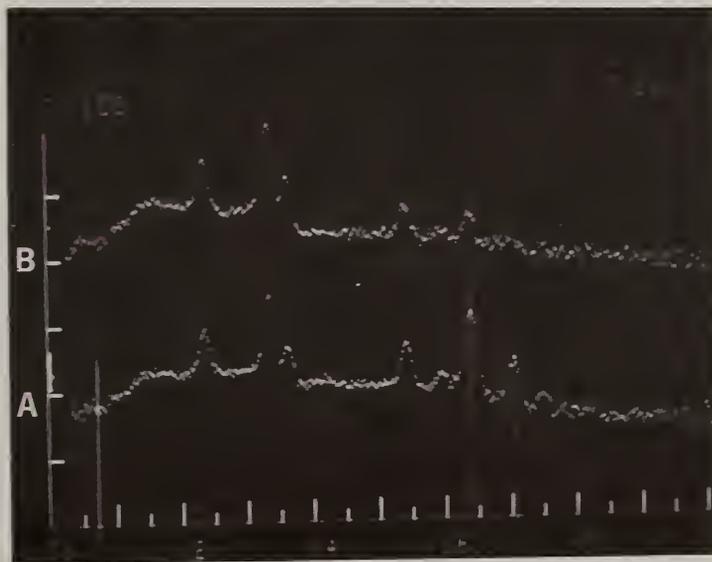
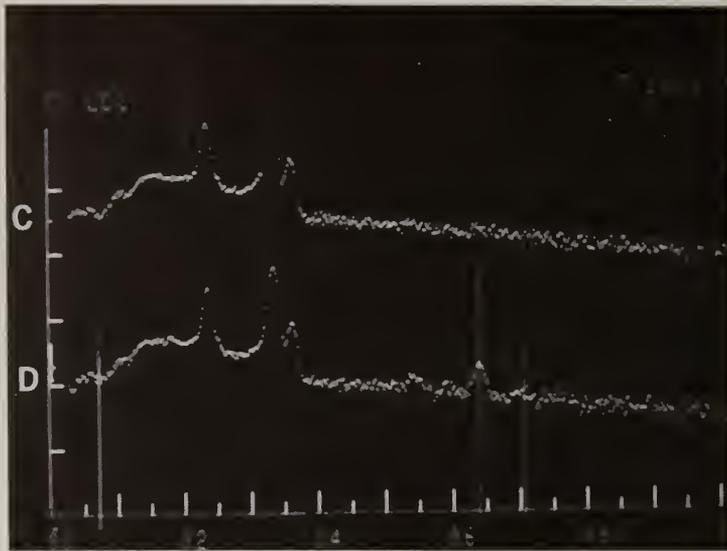
Fig. 10a. EDX spectra of regions A and B of Fig. 10 showing areas of Fe and Cr penetration into an area of potassium and sulfur.

Fig. 10b. EDX spectra of regions C and D of Fig. 10 showing farther penetration of Fe and Cr into the salt deposit region.

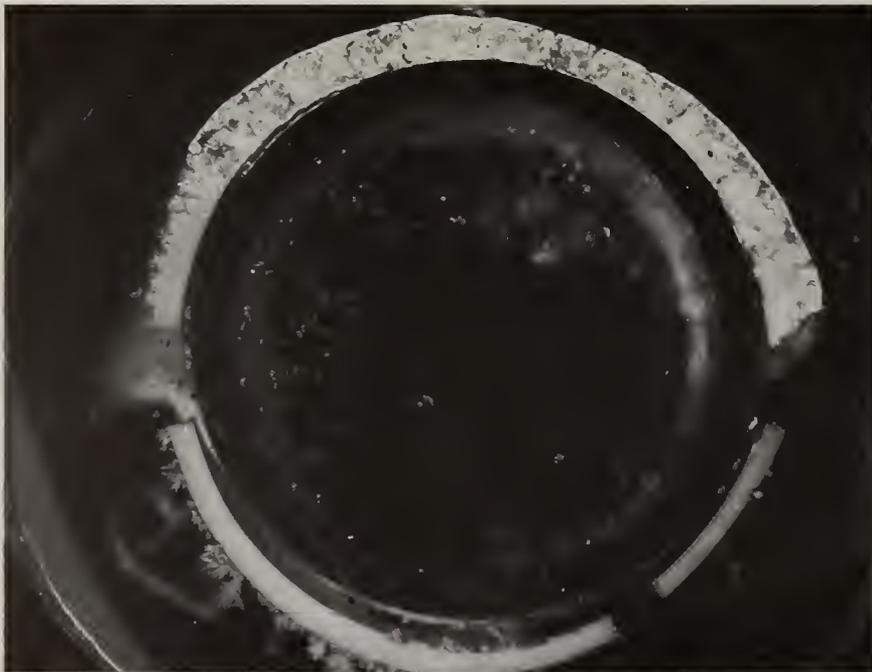
Fig. 11. Section of Type 304 stainless steel tubing after exposure to  $K_2CO_3/K_2SO_4$  seeded fuel rich hot gas stream. Note formation of 0.8 mm deposit on upper surface. Tube temperature 400°C. 6 X.

In a fuel rich hot gas stream, a thin, 0.6 to 0.8 mm, as compared to the oxygen rich environment, salt deposit was formed. As noted in the oxygen rich series these samples also exhibited decreasing thickness with increasing temperature. In contrast to the oxygen rich specimen the fume deposit, 0.4 to 0.7 mm (the layer on the under side of the tube), was heavier. However, it also decreased with temperature, Figures 11, 12 and 13.

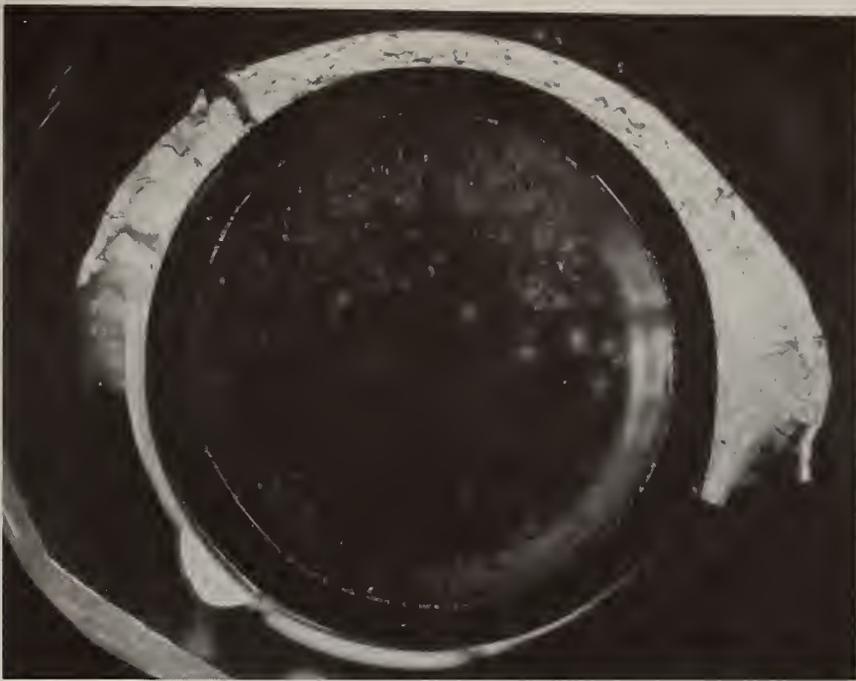
Fig. 12. Section of Type 304 stainless steel tubing after exposure to  $K_2CO_3/K_2SO_4$  seeded fuel rich hot gas stream. Tube temperature  $500^\circ C$ . 6 X.

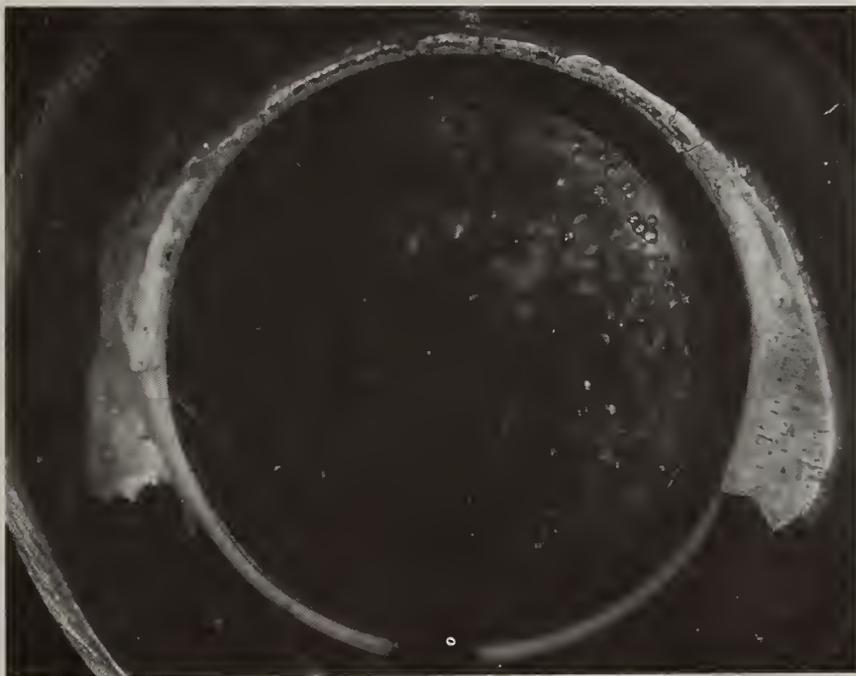
Fig. 13. Section of Type 304 stainless steel tubing after exposure to  $K_2CO_3/K_2SO_4$  seeded fuel rich hot gas stream. Note formation of thin deposit on upper surface. Tube temperature  $590^\circ C$ . 6 X.

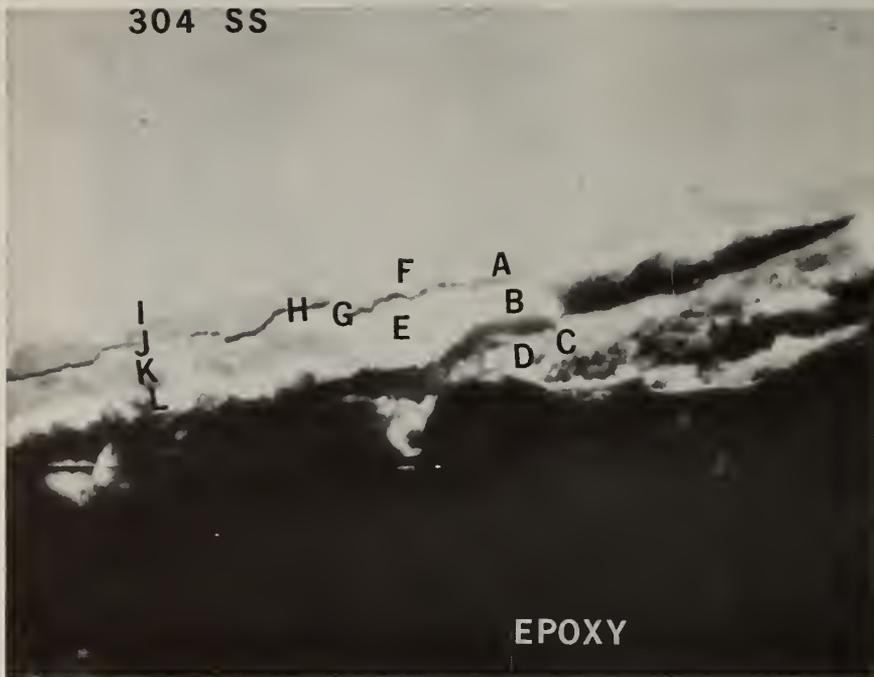
Fig. 14. SEM micrograph, 2000 X, of stainless steel-salt deposit reaction zone. Lettered regions correspond to labeled EDX spectra, Figs. 14a to 14f. Specimen temperature 500°C; gas stream fuel rich.

As in the oxygen rich test samples the fuel rich samples also exhibited reaction zone areas. Again, these areas showed increased activity in corrosion with increased sample temperature. Figure 14, specimen temperature 500 °C and Figure 15, specimen temperature 590 °C show areas of corrosion at the stainless steel/salt interface with areas of high metal cation concentration. However, the reaction areas do not seem to be as great under the fuel rich conditions as compared to the oxygen rich conditions.

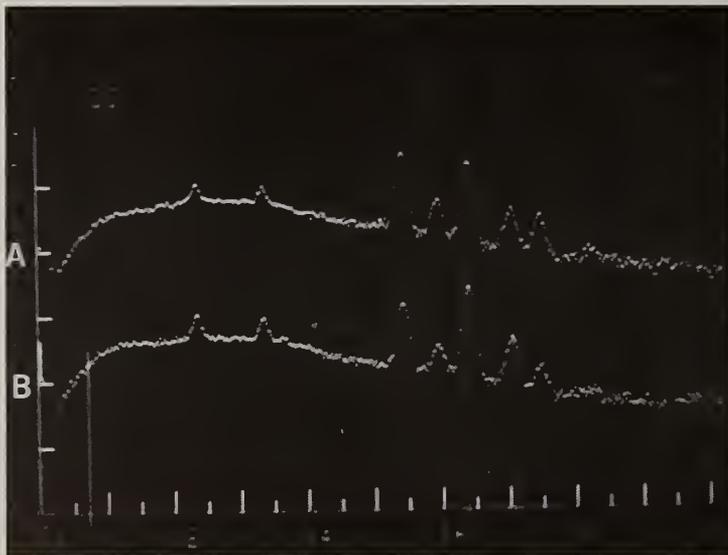
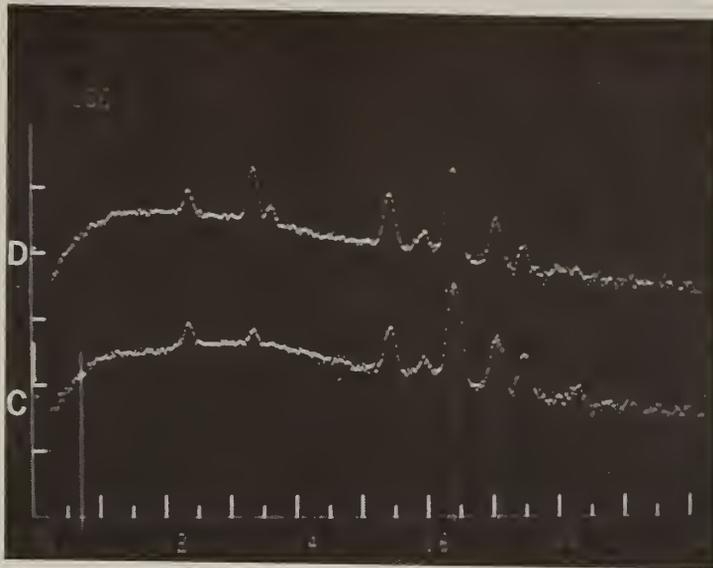
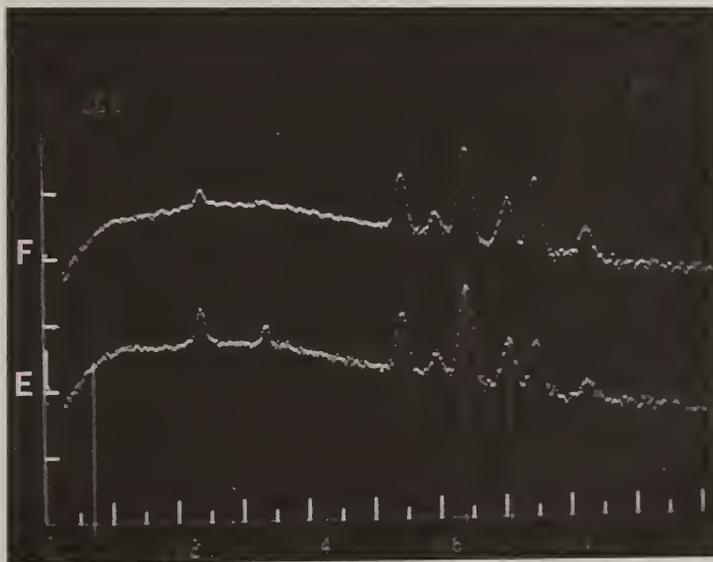
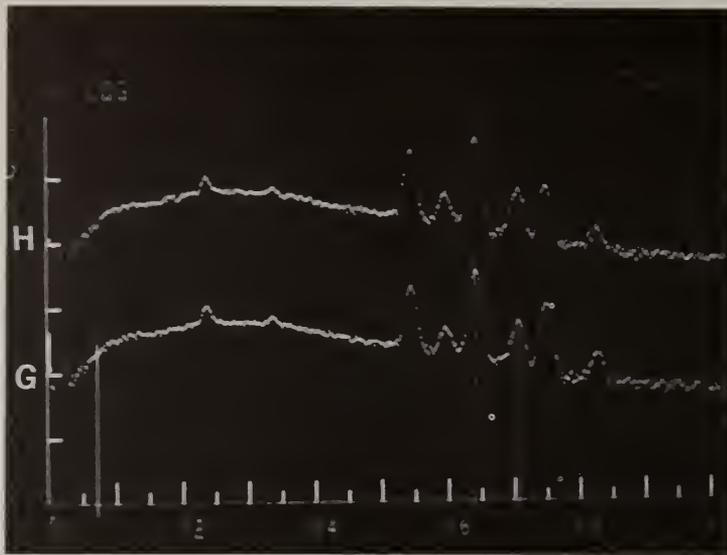
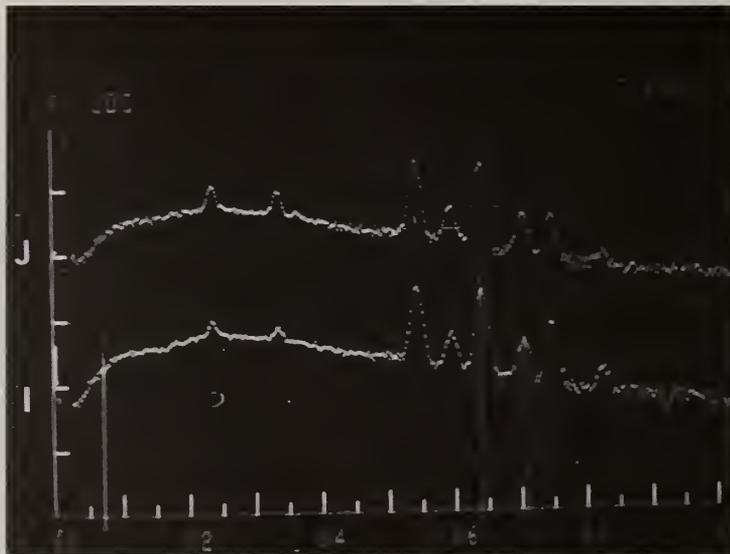
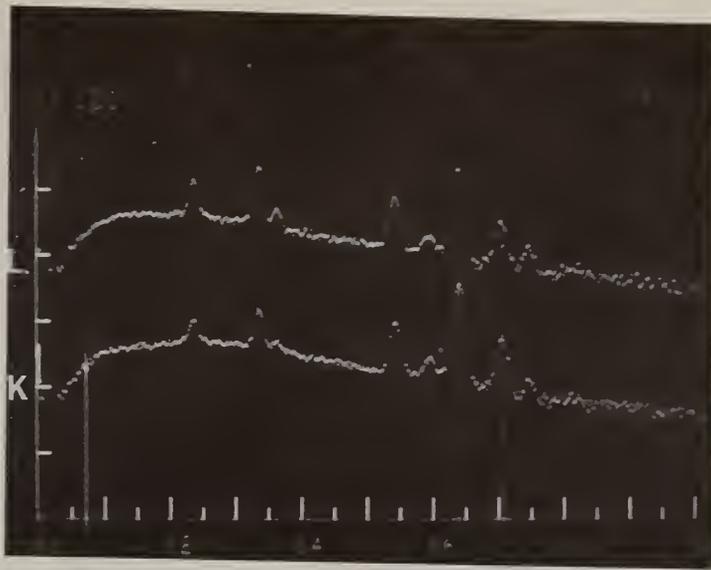
Fig. 14a. EDX spectra of regions A and B of Fig. 14 pointing out areas of high Cr concentration and low Ni concentration on the stainless steel interface.

Fig. 14b. EDX spectra of regions C and D of Fig. 14 indicating areas of low Cr and low Ni concentration at the stainless steel interface.

Fig. 14c. EDX spectra of regions E and F of Fig. 14 showing areas of high Ni and low Cr concentration at the stainless steel interface.

Fig. 14d. EDX spectra of regions G and H of Fig. 14 showing areas adjacent to E and F of high Ni concentration and low Cr concentration.

Fig. 14e. EDX spectra of regions I and J of Fig. 14 showing areas of high Ni and high Cr concentration at the interface.

Fig. 14f. EDX spectra of regions K and L of Fig. 14 of areas below I and J showing low Cr and low Ni concentration.

As noted by SEM/EDX analysis, Figures 14a-14g and Figures 15a-15g, the edge of the stainless steel bulk material contains regions of high chrome concentration followed by areas of high nickel concentration. Areas of high iron concentration are found next, with iron and potassium in the salt deposit adjacent to the stainless steel. The salt deposit seems to contain more sulfur than in the oxygen rich cases, but both have a crust of potassium and sulfur in high concentration on the top of the salt layer.

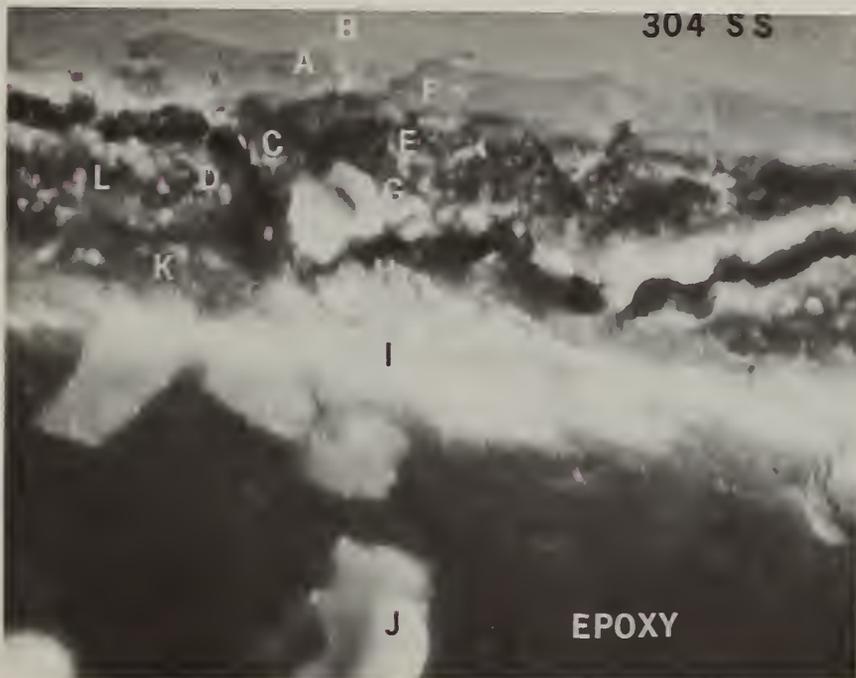
Fig. 15. SEM micrograph 2000 X, of stainless steel-salt deposit reaction zone. Lettered regions correspond to labeled EDX spectra, Figs. 15a to 15f. Specimen temperature 590°C gas stream fuel rich.

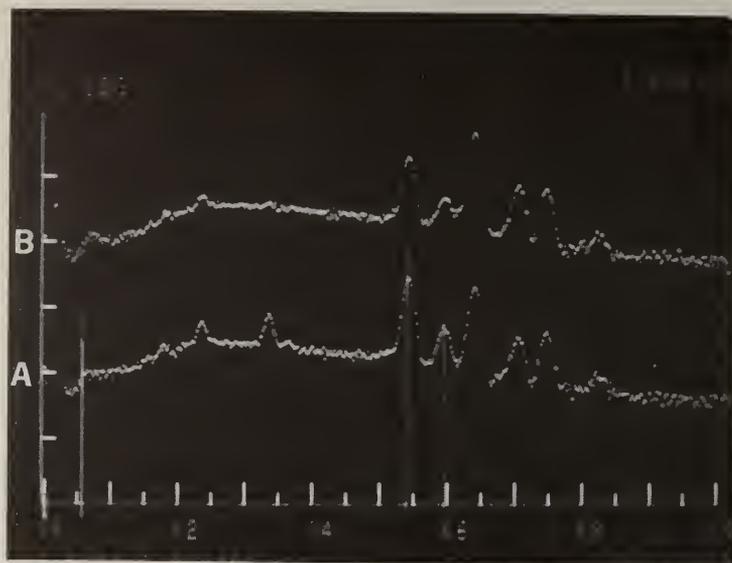
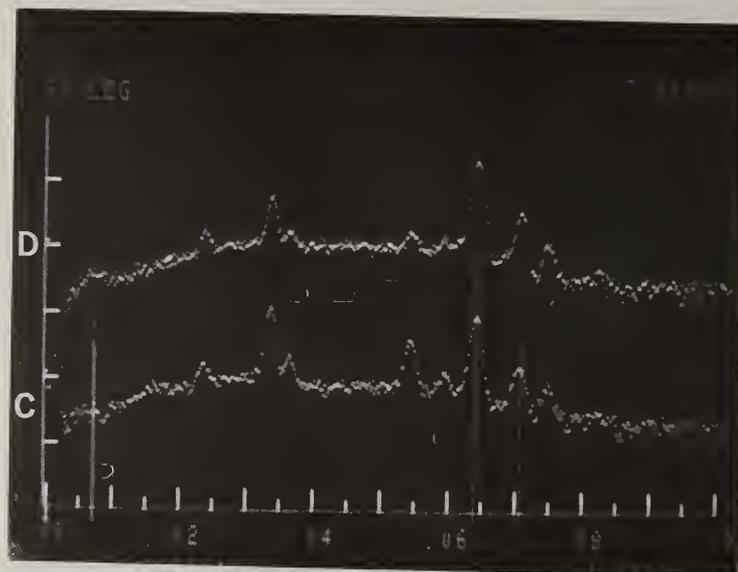
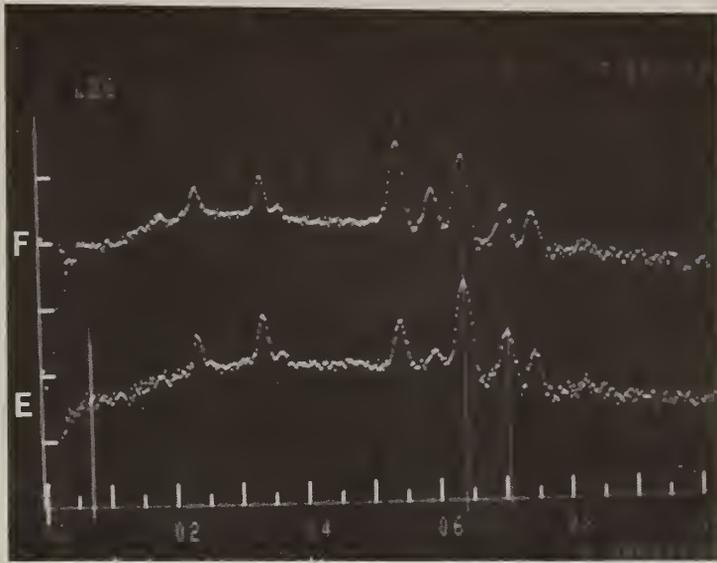
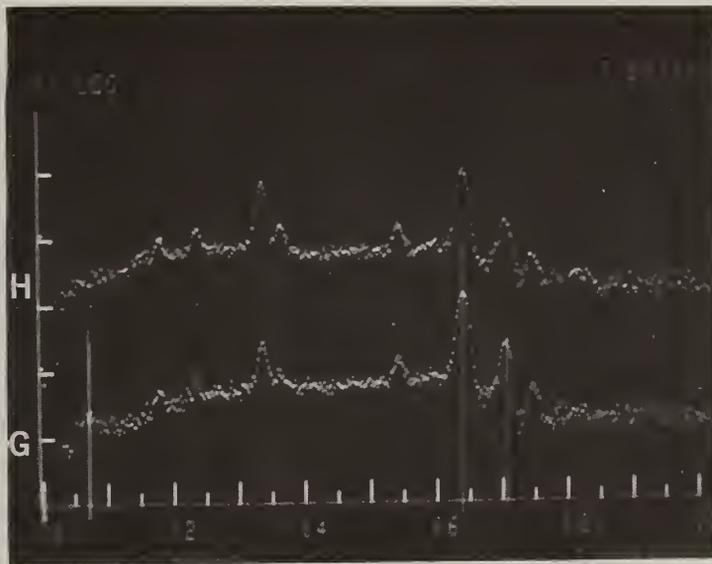
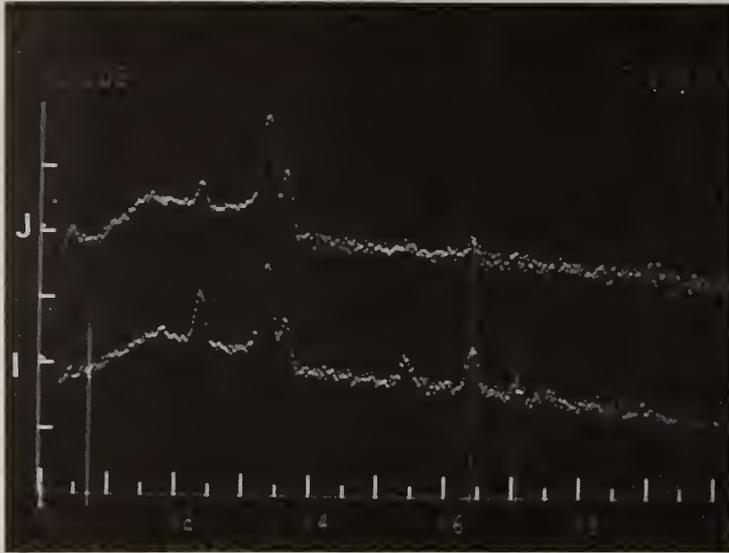
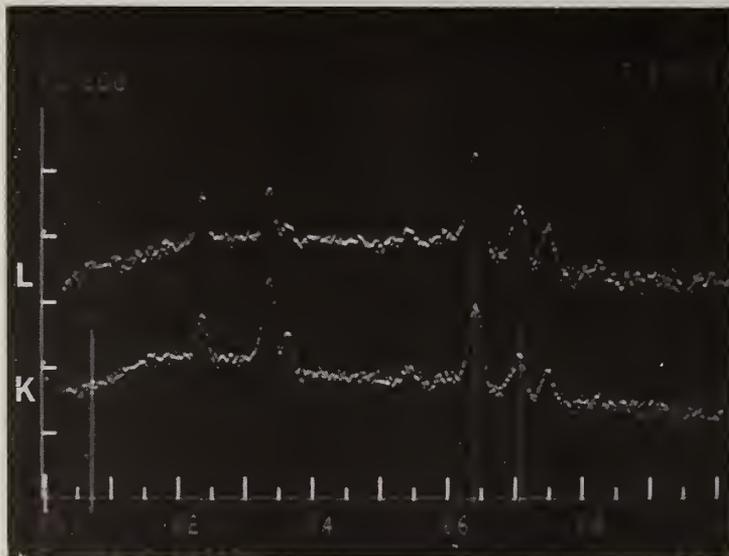
Fig. 15a. EDX spectra of regions A and B of Fig. 15 showing area of high Cr and high Ni concentration as compared to bulk stainless steel.

Fig. 15b. EDX spectra of regions C and D of Fig. 15 showing areas of high Fe, low Ni and low Cr concentration at the stainless steel-salt interface.

Fig. 15c. EDX spectra of region E of Fig. 15 indicating area of high Cr concentration with Ni and region F of Fig. 15 showing area of low Cr concentration with high Ni concentration.

Fig. 15d. EDX spectra of regions G and H of Fig. 15 showing areas of high Fe and low Ni and low Cr concentrations at the stainless steel-deposit interface.

Fig. 15e. EDX spectra of regions I and J of Fig. 15 showing Fe and Cr penetration into the salt deposit.

Fig. 15f. EDX spectra of regions K and L of Fig. 15 showing areas of high Ni and low Cr concentration at the stainless steel-salt interface.

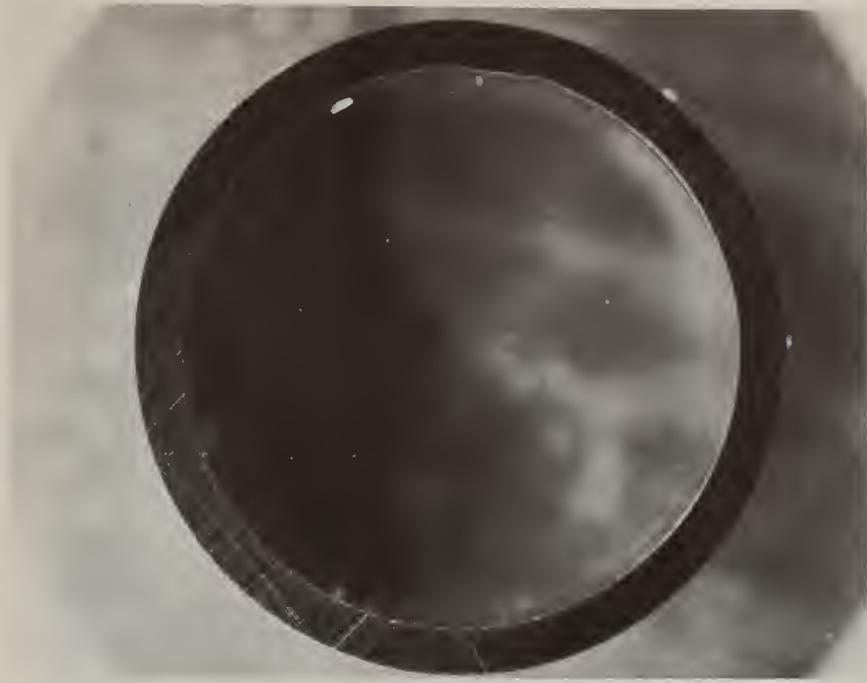
Fig. 16. Section of Type 304 stainless steel prior to exposure to the seeded hot gas stream. 6 X.

Stainless Steel Reference Specimen - As with most analytical techniques, reference samples are used to check some stage of the analysis. At the present time a randomly selected sample type 304 stainless steel that has been cleaned, cut and polished has been used to check outer edges or surfaces for areas where corrosion would most likely occur. A general overview of the tube (Figure 16) would seem to indicate that the 304 stainless is very clean and uniform on the outer edges. However, Figures 17 and 18, shows that in the manufacturing, rough surfaces, i.e., holes and pit areas, can occur. These areas would be more susceptible to a corrosion process and promote deterioration of the surface under hot plasma and seeding conditions. Therefore, not all areas analyzed for pits and holes are necessarily due to the corrosion process. EDX analysis shows that traces of sulfur are already present in the matrix. No other inconsistencies such as areas of high chrome concentration or high iron concentration are found in the metal, but rather a uniform distribution of chrome, iron and nickel is found throughout the 304 stainless steel.

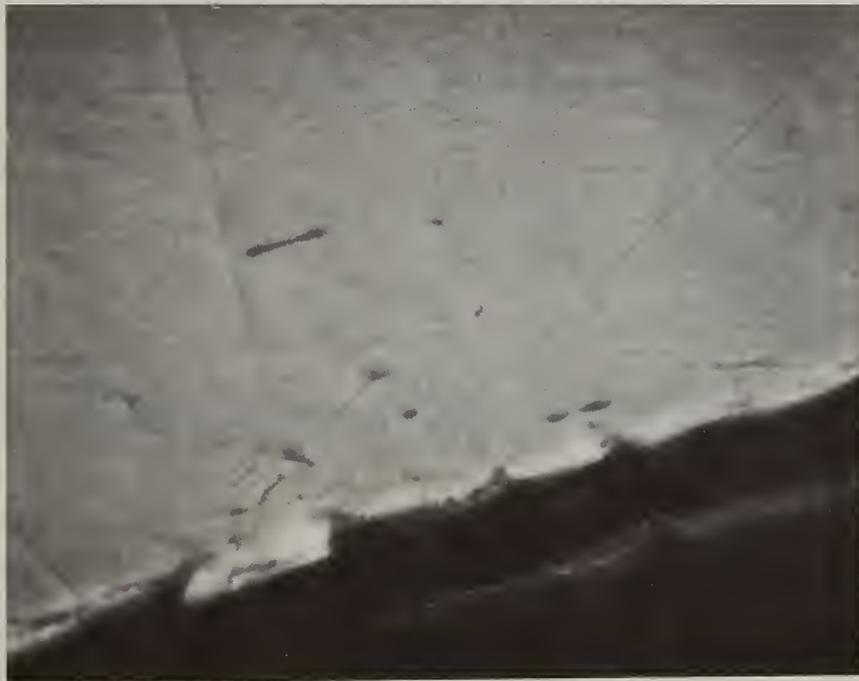
Fig. 17. SEM micrograph 4500 X, of section of Fig. 16 showing stainless steel edge.

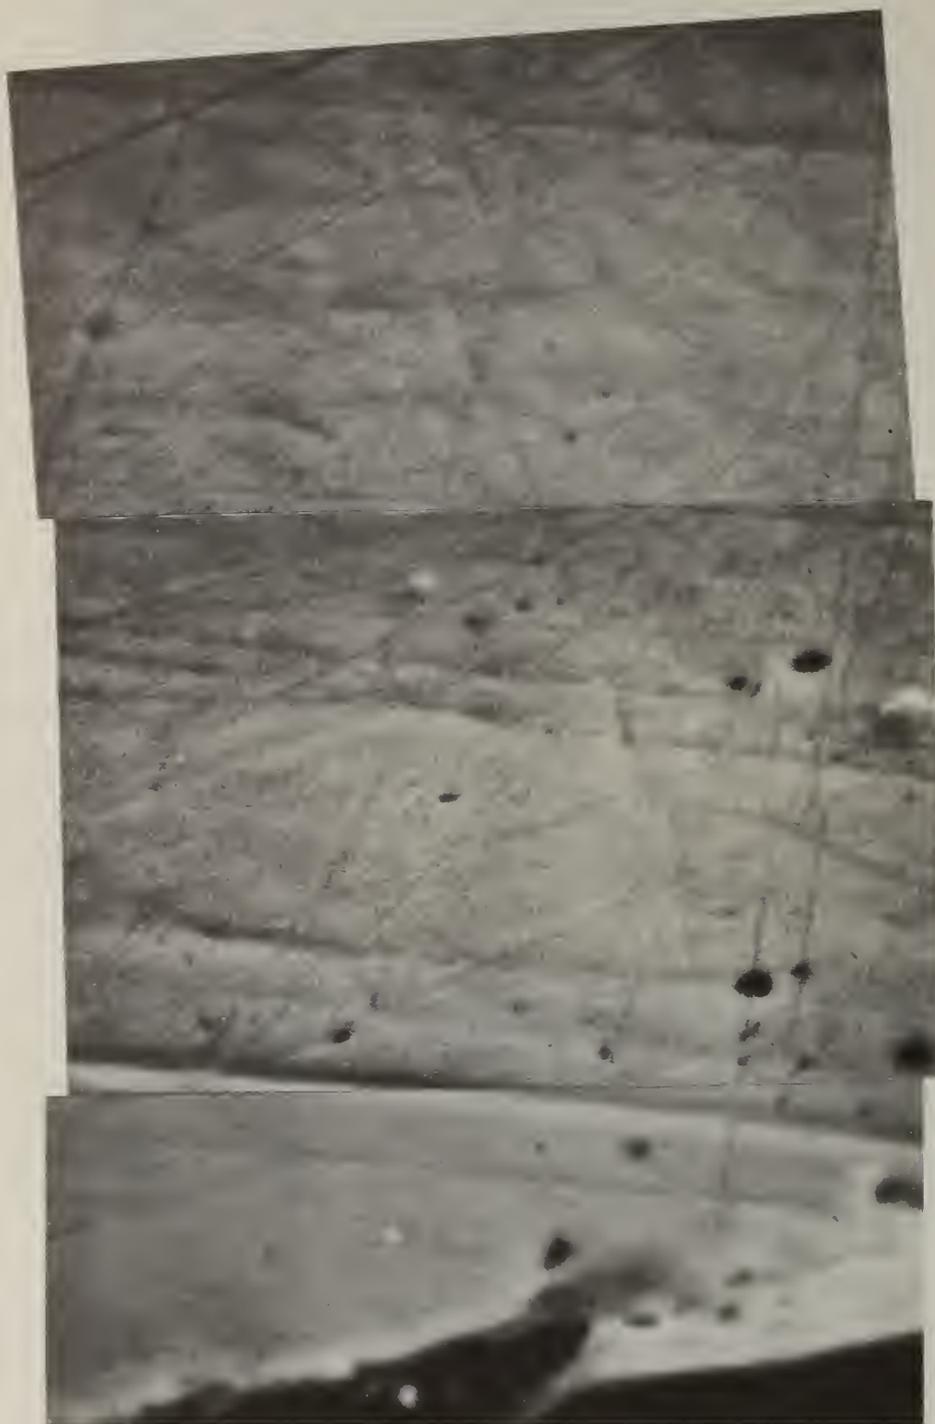
Fig. 18. SEM micrograph (montage) 9000 X, of a section of Fig. 16 showing inclusions and pits in the stainless steel.
